USASC TECHNICAL REPORT  
TR 79-2  
APRIL 1979

# **CRASH SURVIVAL EVALUATION OF THE RU-21B**

PREPARED BY THE U.S. ARMY SAFETY CENTER, FORT RUCKER, ALABAMA

**CRASH SURVIVAL EVALUATION  
OF THE RU-21B**

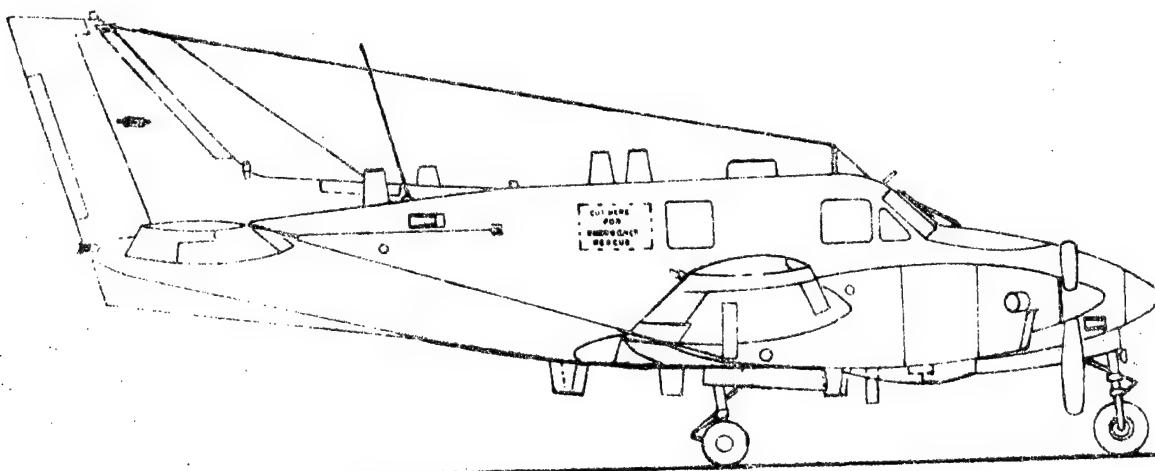
FIGURE 3

The aircraft has numerous antennae located on the bottom and top of the main fuselage (See Figure 3). The lower antennae are highly susceptible to crash damage with resulting arcing near areas of anticipated fuel spillage.

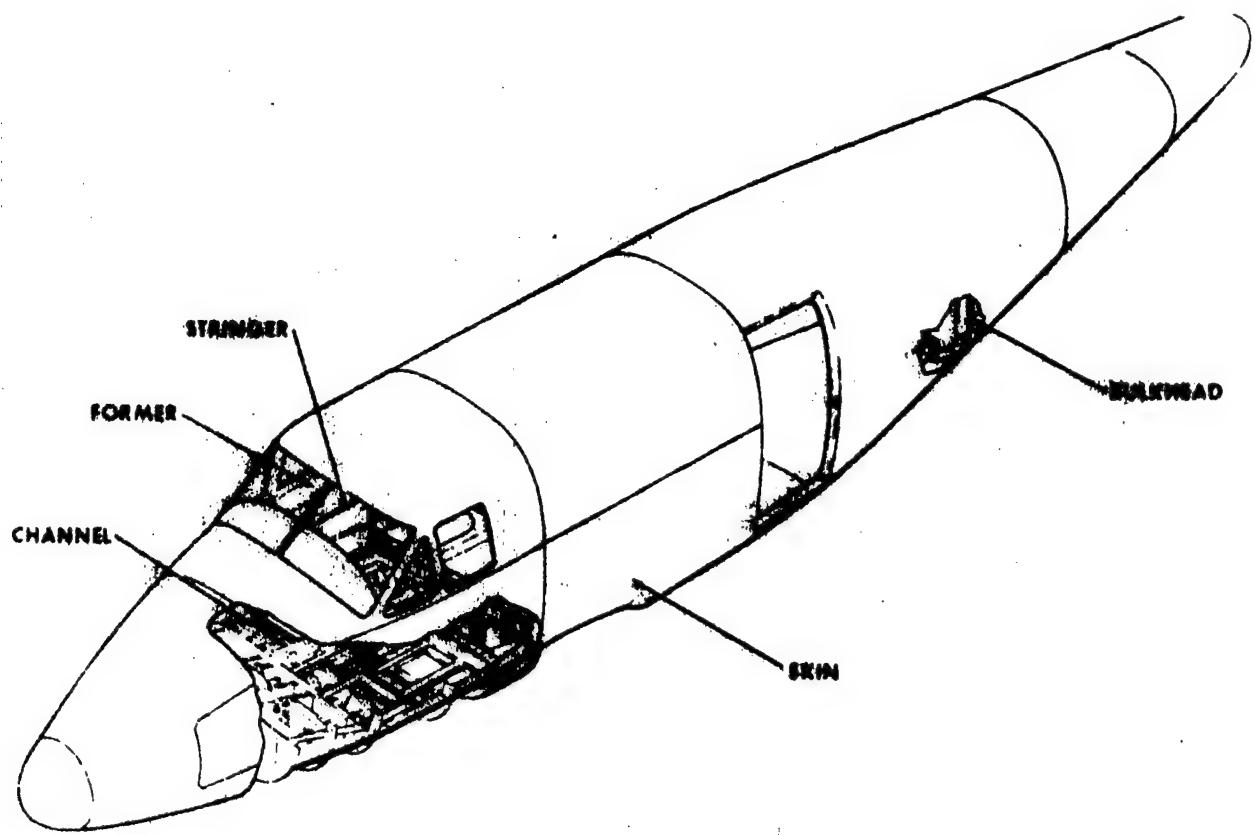
FIGURE 4 -Basic Fuselage Structure

As noted above the fuselage is a semi-monocoque construction consisting of aluminum bulkheads and sheet metal formers and stringers. These and the keel beams in the floor should prevent the floor from buckling in a moderate crash. Resistance to roof collapse is provided by the curved roof members, stringers, and additional longeron above and below the windows on either side of the aircraft.

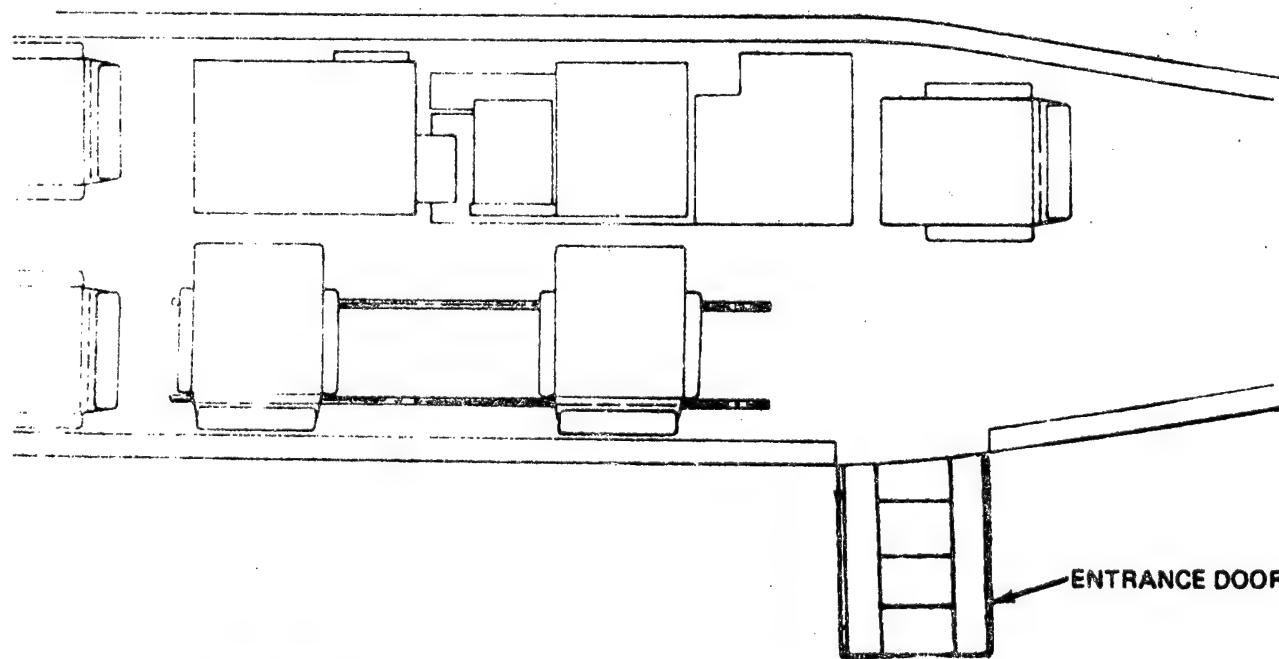
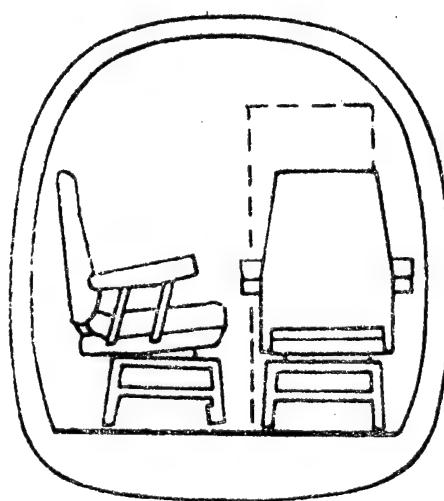
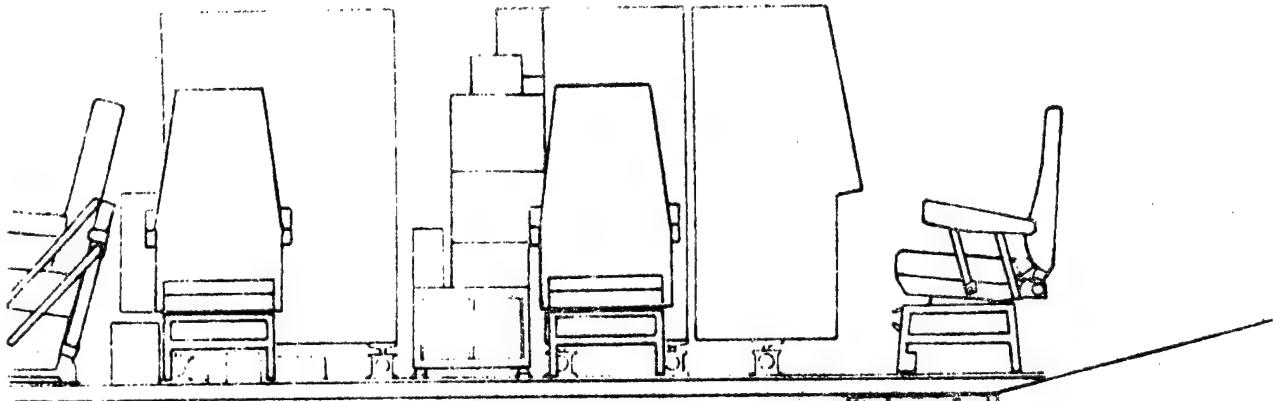
FIGURE 5 -General Interior Arrangement Diagram

The pilot's and copilot's seats of the RU-21B are arranged in a side by side configuration as shown in Figure 5. The seats are adjustable chair type seats having adjustments vertically as well as fore and aft. They are tabular frame construction and attach to a floor mounted rail. The seat bottom and back consists of foam rubber cushions approximately 4" thick. The seat belts attach to two floor disconnect fittings aft of the seats. The shoulder harnesses attach to a roof mounted inertia reel to provide crash restraint. See Figure 6. The reel will lock automatically under a 2 'G' impact or may be manually locked. Seat design is assumed to conform to Reference 2.

Three mission operators seats are mounted in the aft cabin area as shown in Figure 5. A view of the seat is shown in Figure 7. The seats are mounted on tracks near the mission consoles and may be swiveled to allow the operators to face forward, inboard, or aft. The lap belts attach to the seat. No shoulder harness is provided. The seat is assumed to have been designed to Reference 2.

The main cabin door located in the rear of the fuselage (Figure 5) is used for normal or emergency exit. The door is simple to open requiring only a turning motion of the internal or external handle. A removable window is located on the right side of the cabin section but is blocked by mission equipment. Should the main door be blocked or jammed, exit can only be accomplished by breaking out the windshield or cutting a hole in the fuselage at the location shown in Figure 15. Evacuation of the aircraft is greatly handicapped by the internal configuration of the aircraft (Figures 16,17,18). The pilot, copilot, and mission crew members in the forward portion of the cabin have to climb/crawl over seats and/or occupants to exit the aircraft.

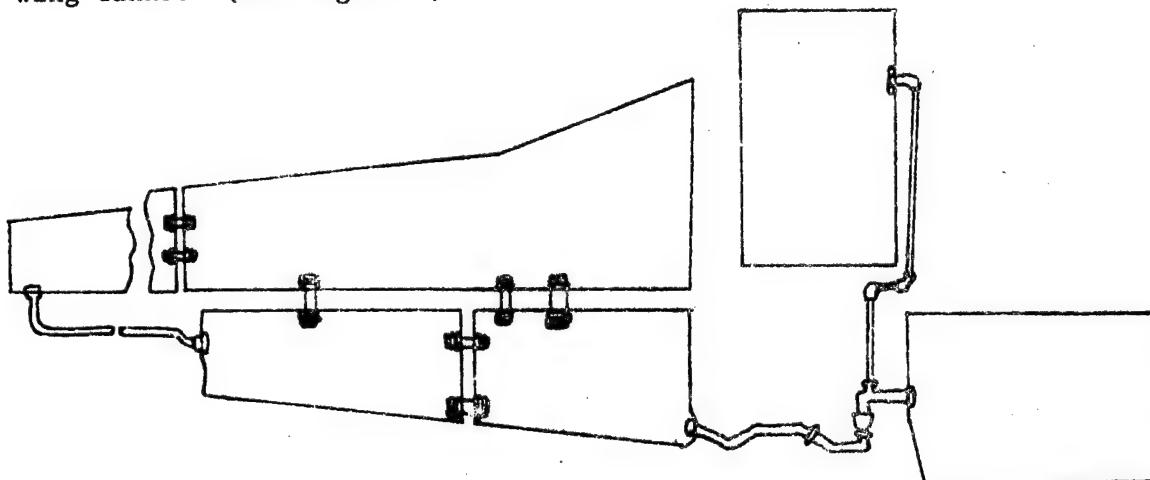
**FIGURE 9 -RU-21B Fuel Containment System (Some interconnecting lines removed for clarity.)**

Because of their location in the wings, the tanks are highly susceptible to damage/rupture/puncture in a crash, especially in rough terrain.

The fuel tanks located in the wings are highly susceptible to crash damage. Many locations such as the filler areas, fuel quantity indicators and vents are rigidly attached to the wing structure and the fuel tank. The tanks are connected by metal coupling. Any deformation in an accident can result in the fittings being torn from the tanks and fuel spillage.

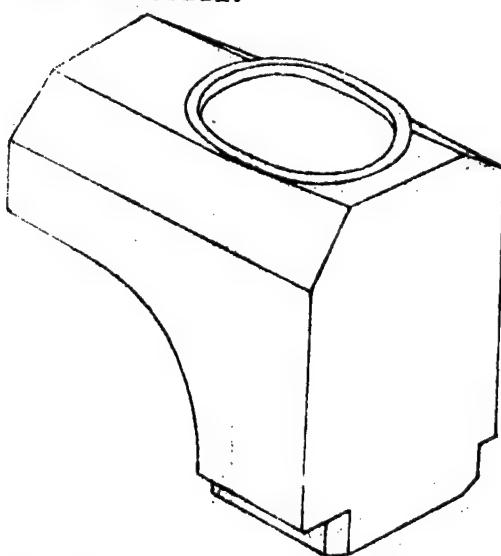
FIGURE 12 -Nacelle Tank Configuration.

<u>d. Fuel Boost System</u>	<u>Optimum Points</u>	<u>System Rating</u>
The electrically driven fuel boost pumps are located in the bottom of the nacelle mounted tanks. This area is highly susceptible to damage in a fire resulting in spilled fuel and an ignition source.	6	0
<u><b>Oil and Hydraulic Fluid Containment</b></u>		
The engine oil system is the only oil system on the aircraft. The engine oil tank is integral with the air-inlet casting located forward of the engine accessory gear box. The capacity of each of these oil tanks is 9.2 quarts.	20	14
<u><b>1. Location</b></u>		
The location of the oil tank is poor. Severe crashes can result in the engine separation and rupture of the tank. The hot engine surfaces can ignite the oil. Though this would represent only a small fire, it is located near the main fuel tanks and could ignite the fuel spillage. Points are therefore granted only for the location away from occupiable areas.	7	2

Electrically driven fuel boost pumps are located in the bottom of each nacelle fuel tank. Electrically driven boost pumps, especially those located in an area susceptible to damage, are undesirable.
